# Manhole Inspection Summary

Manhole # S21G\_\_009MH

Insp Date: **8/23/07 11:35 AM**

**Location** Address: **25 FULTON-BRUCE**

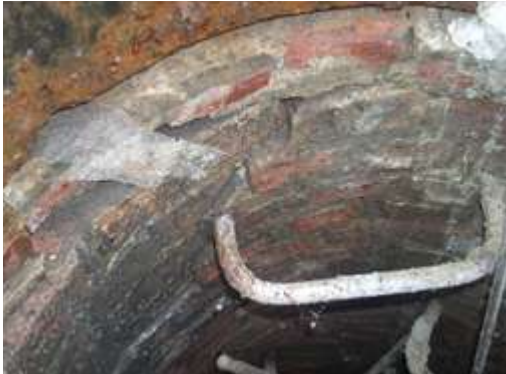
Defect 4

Condition: ☐ Sound ☒ **Cracked** ☐ Root Intrusion ☐ Loose Brick ☐ Deteriorated

LARGE CRACK RUNNING FROM THE JOINT DOWN INTO THE CORBEL

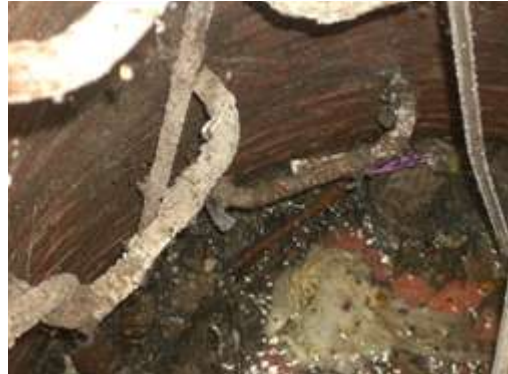
Defect 3

**Steps** Count: **4** Missing: **0** ☒ **Corroded**

**Surcharge** ☒ **Evidence Of Surcharge** Depth: **2** (ft.) ☐ Active Surcharge Present

CORRODED STEP WITH SURGE EVIDENCE

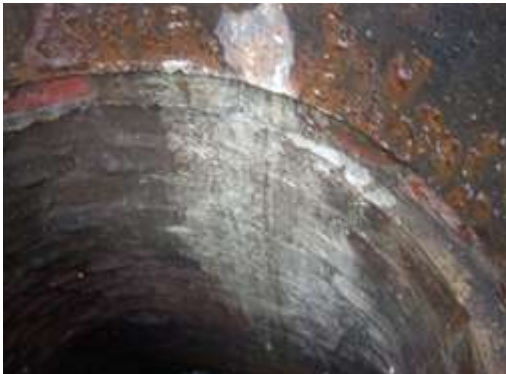
Defect 2

Infiltration: ☐ None ☒ **Joint** ☐ Cracks ☐ Mortar ☐ Roots ☐ Wall

INFILTRATION OF THE JOINT

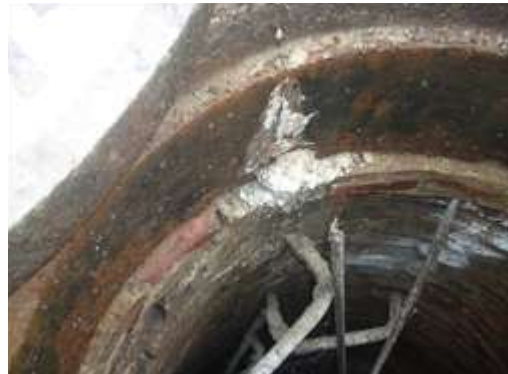
Defect 1

**Frame** Offset: **1** (in.) Condition: ☒ Sound ☐ Cracked ☐ Leaks

FRAME OFFSET

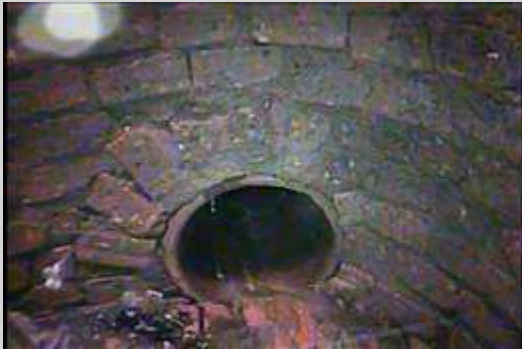
12 O'Clock Outflow

8 in. Circular Gravity Sewer  
Pipe Out @ 12 O'Clock

Pipe Height: **8.4** (in.) Rod and Bar (Angled)  
Pipe Material: **Clay** ☐ Pipe Lined  
Invert Depth: **7.01** (ft.) Flow Characteristics: **Slow**  
Deposits: ☒ None ☐ Mud ☐ Sludge ☐ **Debris** ☐ Grease  
Silt Depth: (in.) Deposits Extent:  
Infiltration: **Evidence** Pipe Seal Cond: **Sound**

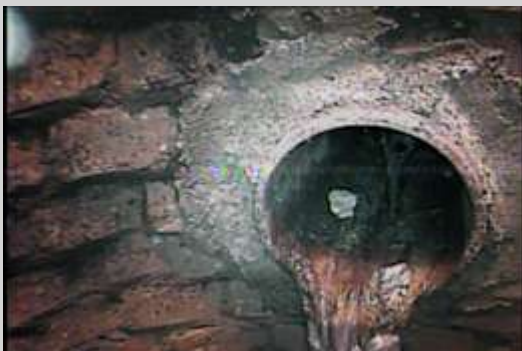
6 O'Clock Inflow

6 in. Circular Gravity Sewer  
Pipe In @ 6 O'Clock

Pipe Height: **6** (in.) Rod and Bar (Angled)  
Pipe Material: **Clay** ☐ Pipe Lined  
Invert Depth: **5.03** (ft.) Flow Characteristics: **Fast**  
Deposits: ☐ None ☐ Mud ☐ Sludge ☒ **Debris** ☐ Grease  
Silt Depth: **2** (in.) Deposits Extent: **Light**  
Infiltration: **None** Pipe Seal Cond: **Sound**
